OKACOM LOOKS AT

Land use on the Cubango-Okavango Basin

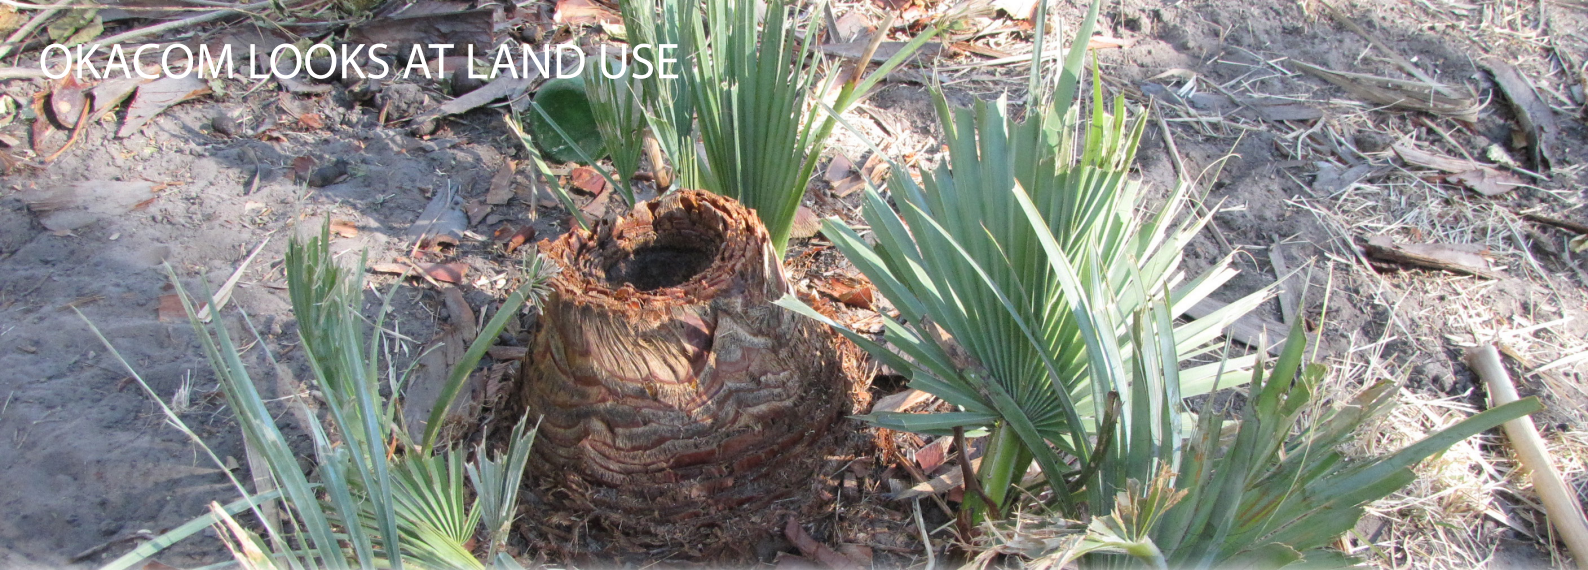
The progressive increase in the mosaic of croplands in different parts of the upper Cubango River

IN 1973, settlements and cropland were relatively small and isolated, as shown by the white patches among the overall red colouration, which indicates high vegetation cover.

BY 2003, the crop field areas have been extended, although the woodland ridge between the Cutato and Cuchi Rivers remains relatively undisturbed.

Satellite images of land use at three river sites over a 25-year period show a decline in upper basin forest cover and ever-increasing crop areas in the lower riparian zones.
